# Case Study #1

The Edmond family own a 1960's single-storey bungalow, with a pile foundation (Type A). They've recently had an inspection completed by a Project Management Office (PMO).

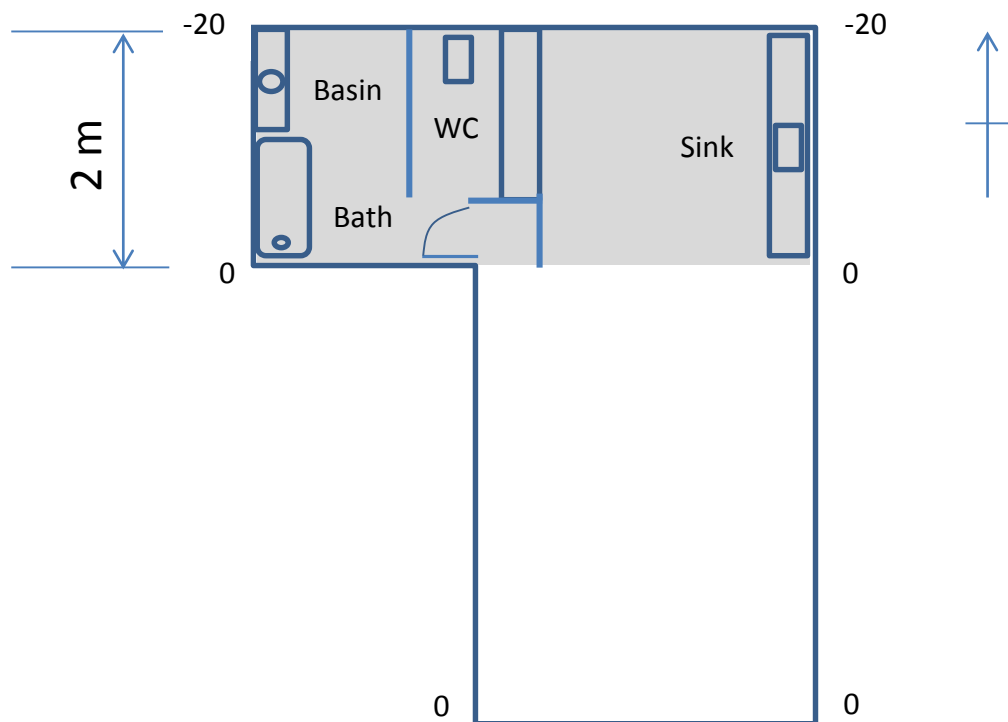
The inspection of the 'above and below floor' condition, including the cladding, revealed no observable damage and confirmed that underground services were intact.

The North wing of the house has sunk 20mm over a 4-metre floor width. Table 2.3 of the GUIDANCE indicates the slump of the North wing of 20mm across 4m to be on the limit of 'acceptable floor slope' ( 1:200 overall or < 0.5% over more than 2m). Therefore, the GUIDANCE indicates that no flooring repair or re-level is required.

However, further inspection revealed that the slope of the floor (and joinery fittings) is enough to cause several problems for the Edmond family. Firstly, water on the kitchen bench will no longer drain into the sink, instead pooling at the end of the bench. Secondly, the bath will now not drain fully, leaving water pooling at the 'non-drain' end. Thirdly, the bathroom door no longer remains open without physical restraint.

These problems, though outside the areas of consideration of the Guidance, were sufficiently inconvenient to the householder to involve either releveling the floor or releveling of the affected bathroom and kitchen fittings and easing the door frame.

The decision was to relevel the floor, illustrating that even though the Guidance may indicate 'no action' from a structural viewpoint, other factors may indicate that some remedial action needs to be taken.
