Case Study #2

John and Trudy own a single-story, brick veneer house on TC2 land. Their home has a Type B foundation (ie perimeter concrete foundation wall and piles beneath the floor). They've recently had an inspection completed by a Project Management Office (PMO).

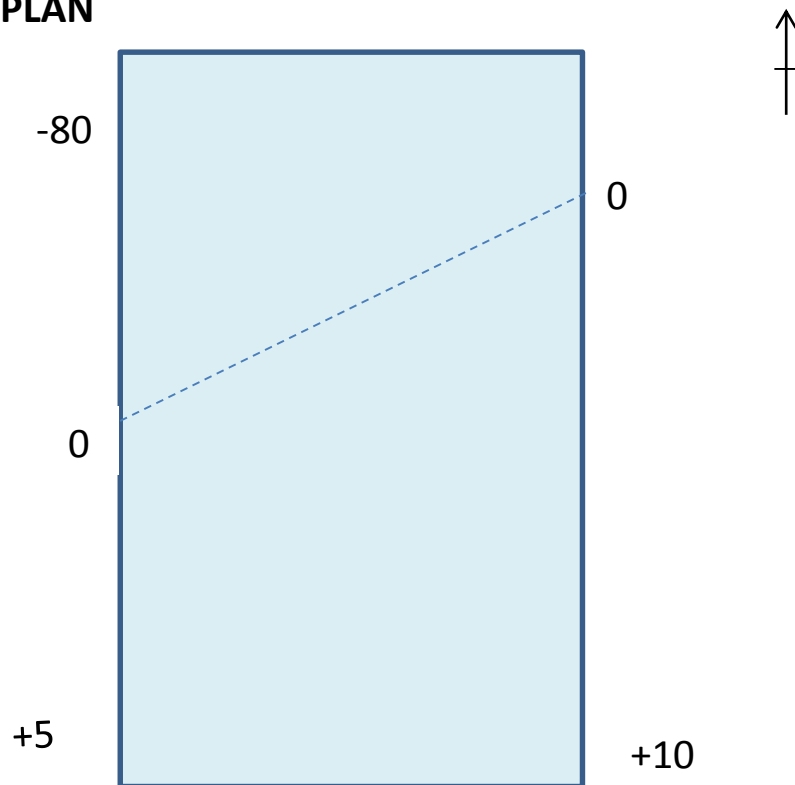
PLAN

The assessment of their home revealed that the house foundation has slumped with an 80mm differential, from the start of the slump to its extreme limit at the north western boundary.

Table 2.3 of the GUIDANCE indicates that the variation in floor level would require a foundation re-level of the north-west corner and subsequent repair of the superstructure. Additionally, a shallow geotechnical investigation showed there is less than 300kPa geotechnical ULS bearing capacity so specific engineering design of the footings will be required prior to the re-level and repair. The building itself has suffered significant damage at the point at which the floor begins to slope.

Overall, the GUIDANCE indicates a re-levelling of the foundation and subsequent superstructure repair, however the onsite assessment by the PMO and Geotechnical Engineer results in John and Trudy being advised that a re-level and repair would be impractical. The overall information gathered from the assessment justifies that a partial foundation rebuild and rebuild of the affected northern part of the superstructure is required.
